Cracking in Concrete

Part I: Causes

Part II: Effects

Kimberly Kurtis, PhD, FACI, FACerS
College of Engineering ADVANCE Professor
Associate Chair of Graduate Programs
School of Civil and Environmental Engineering
Georgia Institute of Technology
Atlanta, Georgia USA

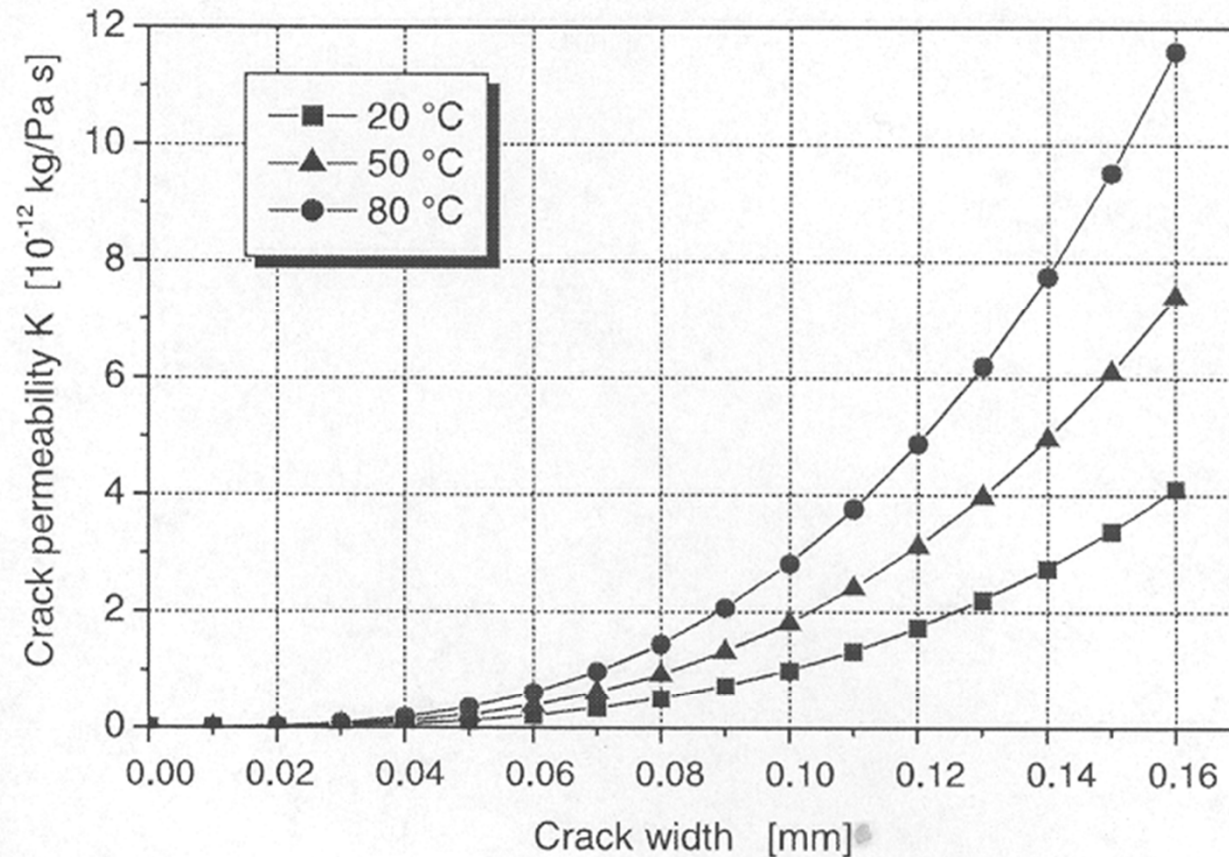
- Permeability is faster through larger crack widths and at higher temperature

Fig. 7. Representation of the dependency of K of Eq. (4.3) on crack width and temperature.

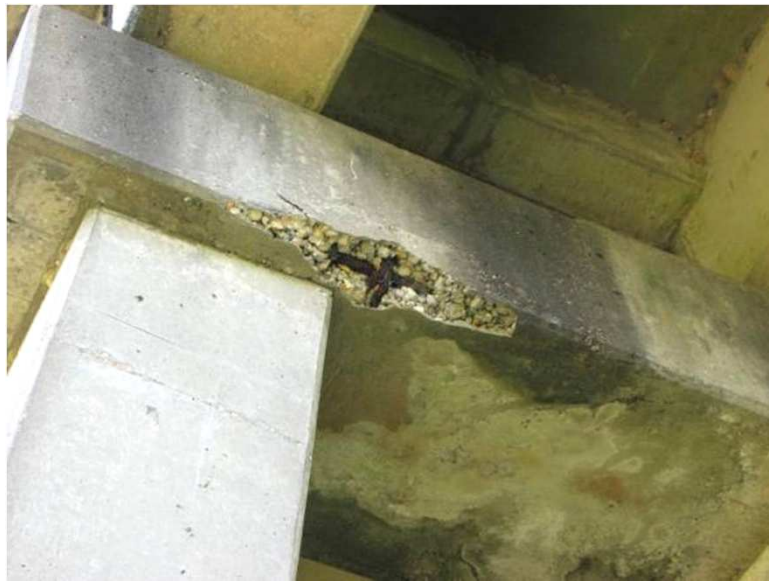
- Rust staining
- Cracking → spalling
- Cover delamination
- Exposed prestressing strands and rebar

US 80 at Lazeratto Creek Bridge

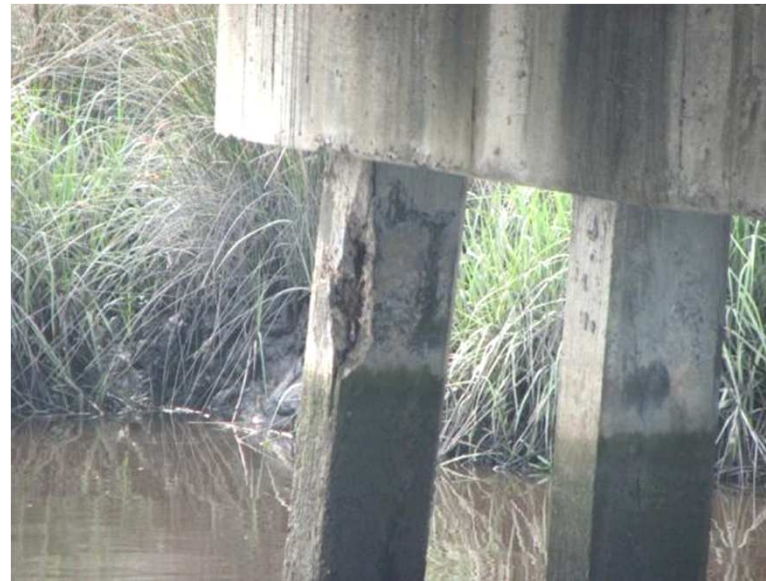
Ocean Highway at Riceboro Creek Bridge

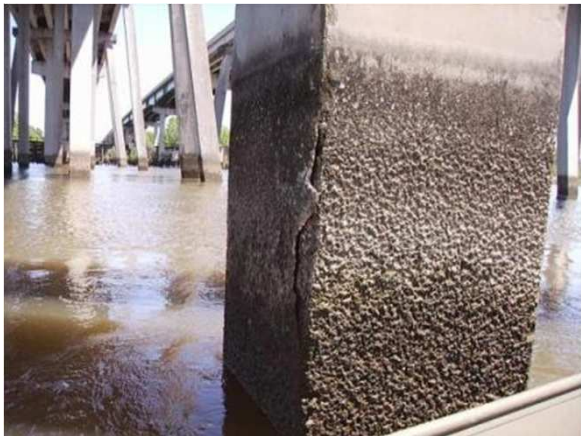
- Rust staining
- Cracking and spalling
- Cover delamination
- Exposed prestressing strands and rebar

I-95 at Savannah River

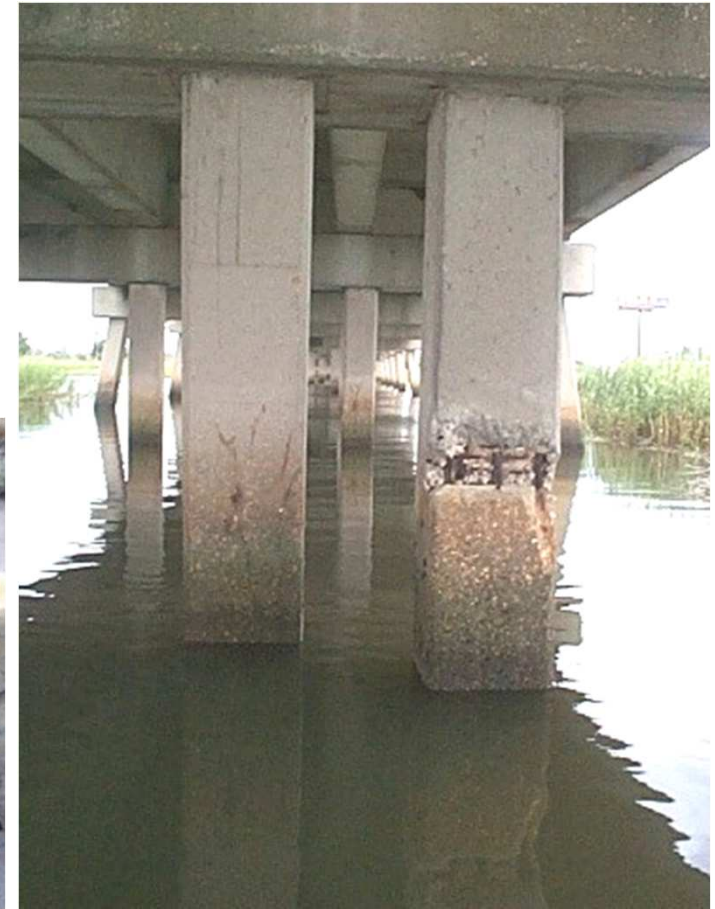
US 17 at Back River Bridge

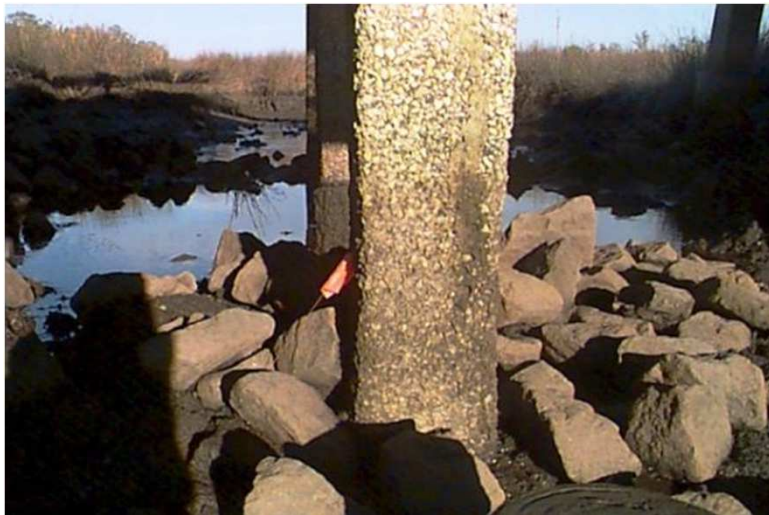
- Surface abrasion due to wave and tidal action
- Particulates or debris suspended in flow
- Impact damage from boats, other objects

Harrell Highway at Buffalo Swamp

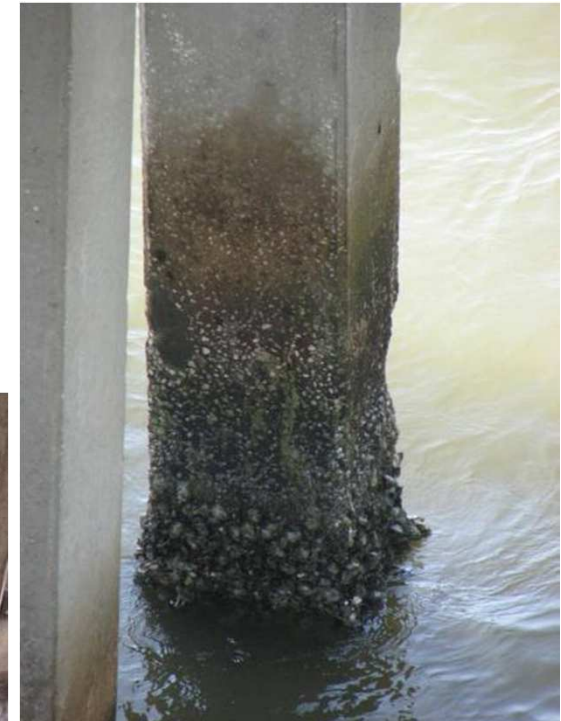
**Island Expressway at
Wilmington River Bridge**

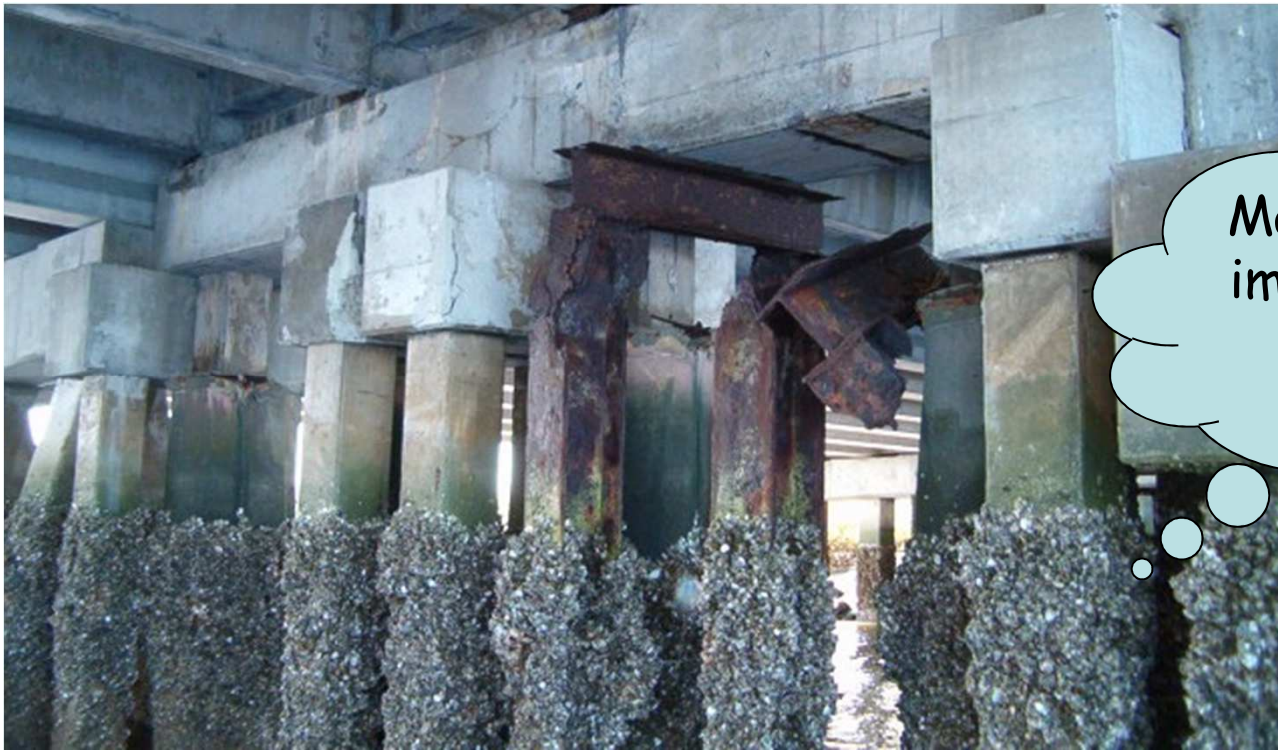
- Marine growth (oysters) in tidal zone
- Marine growth (barnacles, sponges) in submerged region

Marine growth can impede inspection, including diver inspection

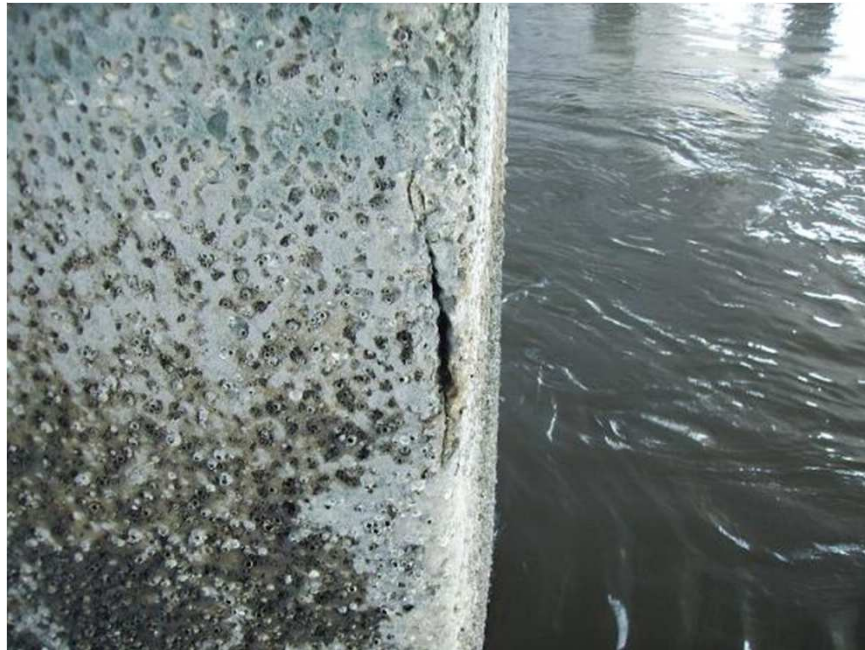
- Softening of concrete
- Surface cracking and spalling of cover concrete
- Efflorescence

Ocean Highway at Champney's River

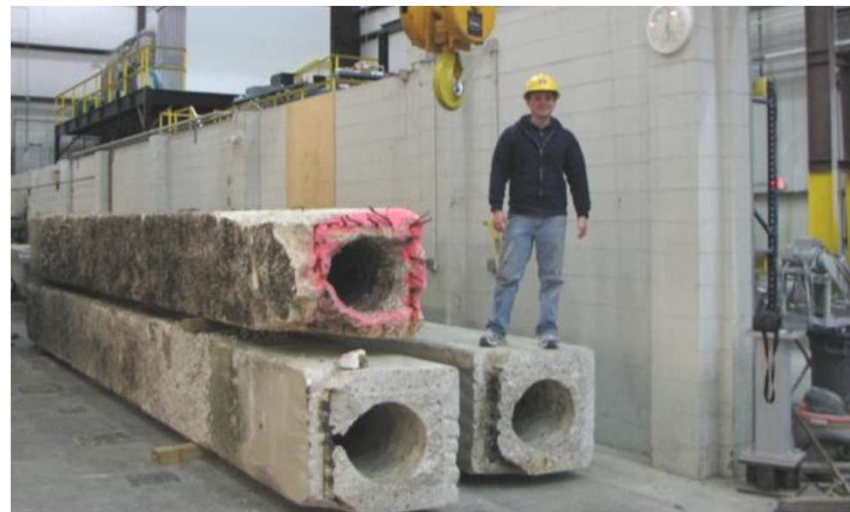
Visual Survey of Damage

Damage found suggests:

- Physical deterioration
- Chemical attack
- Biodeterioration
- Corrosion

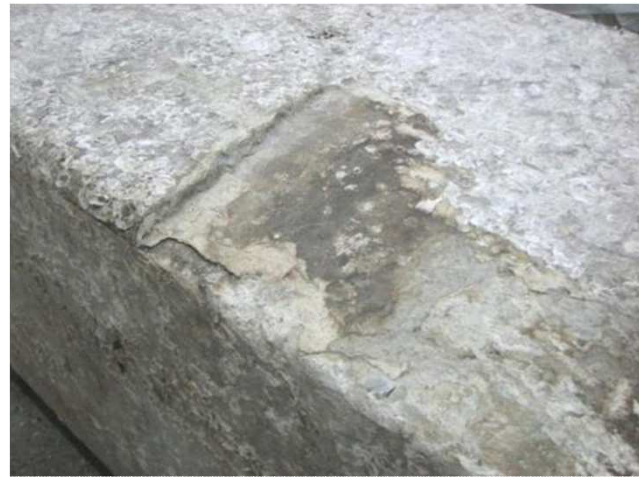
Tidal/splash zone:

- Heavy oyster growth
- Longitudinal cracking at corners
- Spalling at corner strand
- Rust staining; reinforcement loss

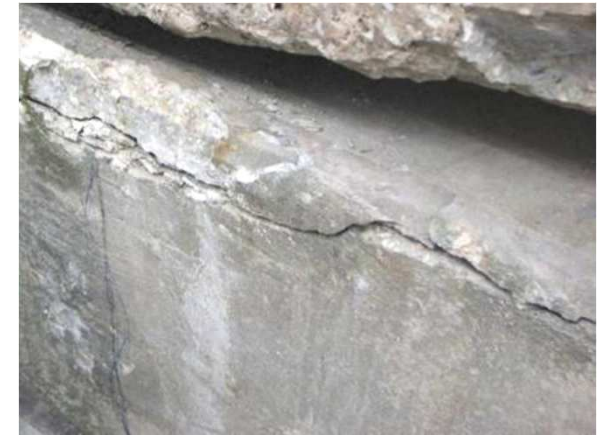
Atmospheric zone:

- Longitudinal cracking

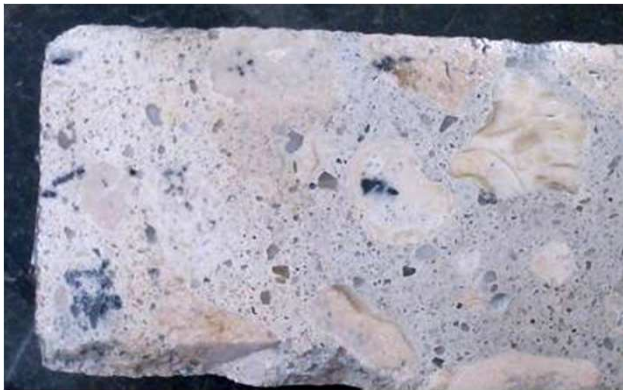
Chemical Attack - Carbonation

- Phenolphthalein pH indicator showed reduced pH of surface concrete in submerged and tidal regions
- Did not reach depth of reinforcement
- Could contribute to reduced strength in near-surface concrete

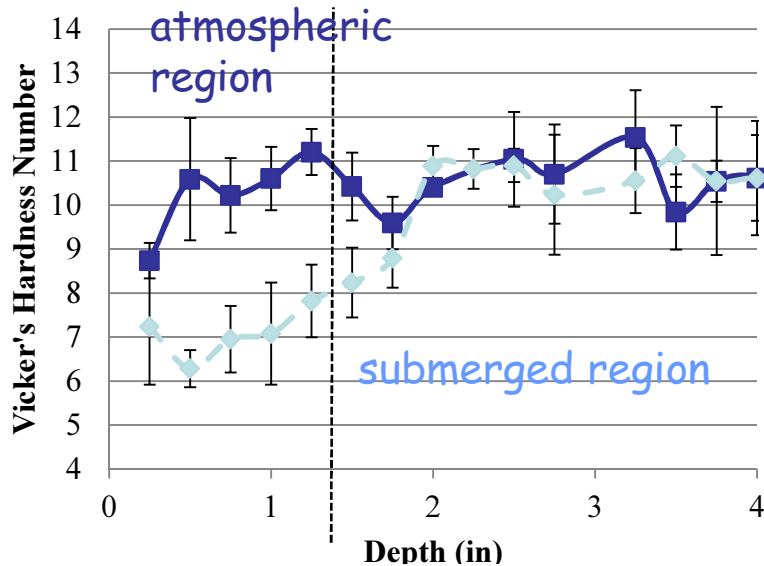
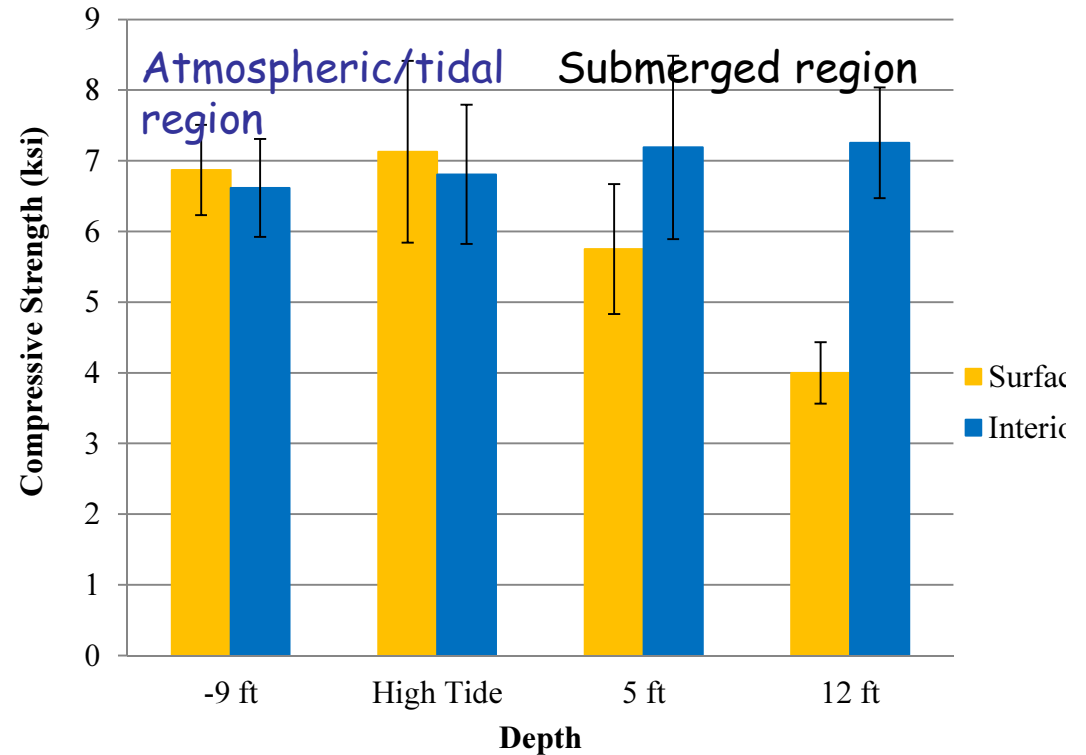
Carbonation rate of $\sim 0.8\text{mm/year}$ in submerged region

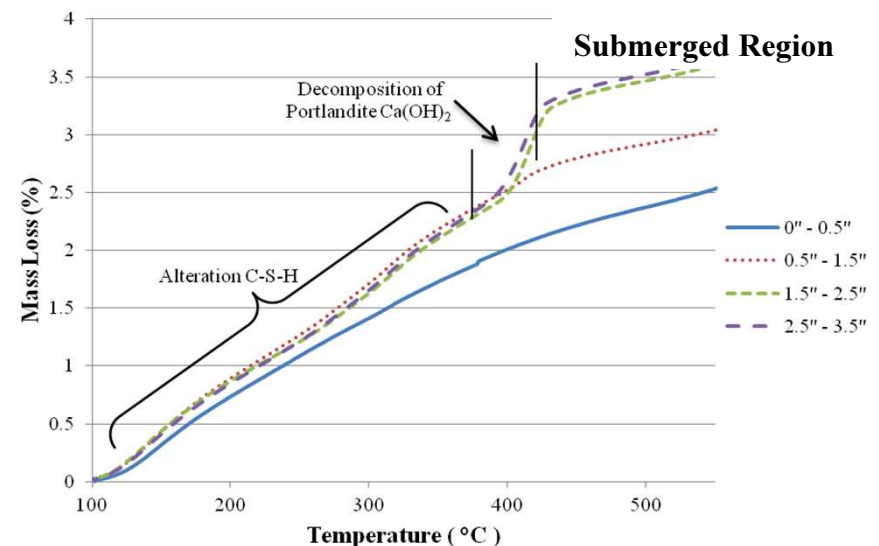
- Loss of portlandite
- Alteration of C-S-H
- Formation of ettringite
- Formation of gypsum

Combination of carbonation and sulfate attack can decrease strength and result in formation of expansive products → cracking, increased permeability

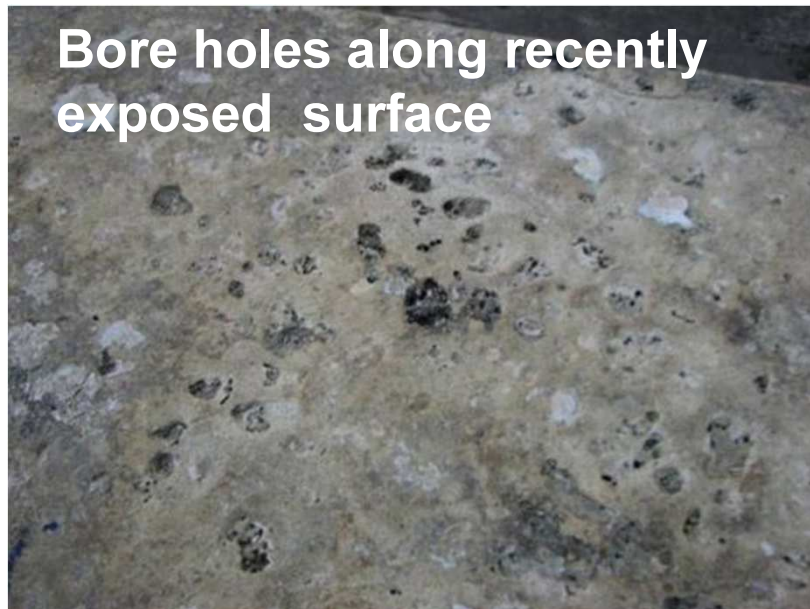
- Biodeterioration evident in submerged regions
- Attack isolated to porous Pleistocene limestone aggregates
 - 70% of cores taken had damage to aggregates
- May result in coupled bio/chemical deterioration

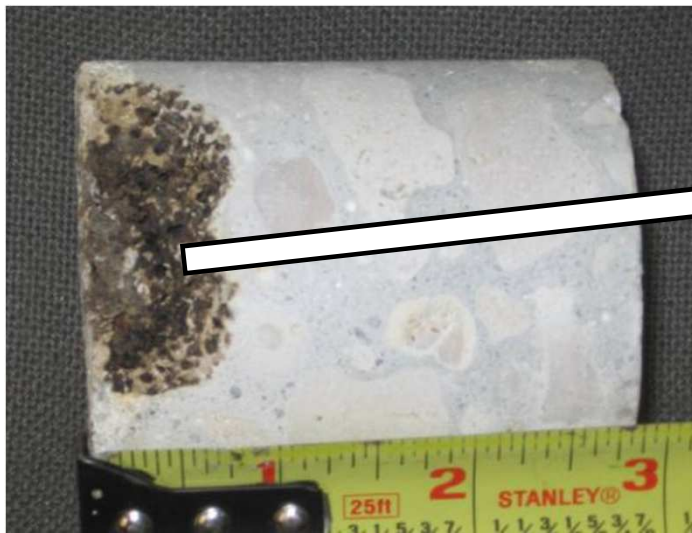
- Boreholes in aggregates examined by ESEM

Loss of coarse aggregate by biodegradation clearly increases local permeability

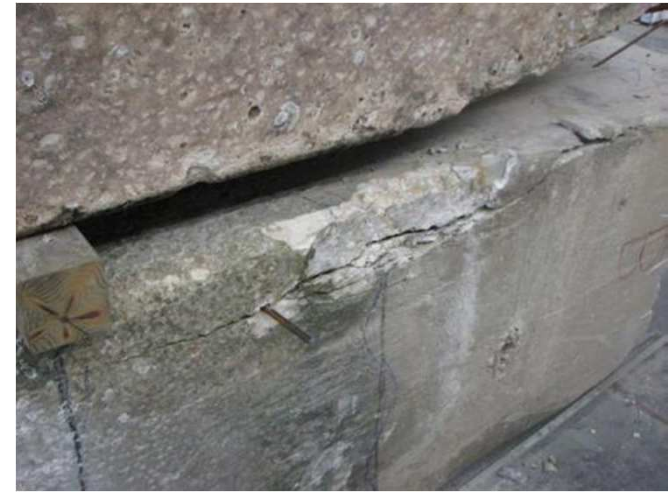
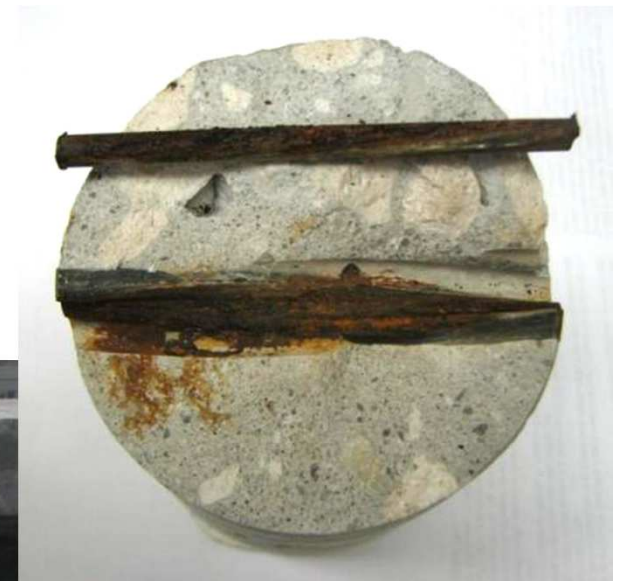
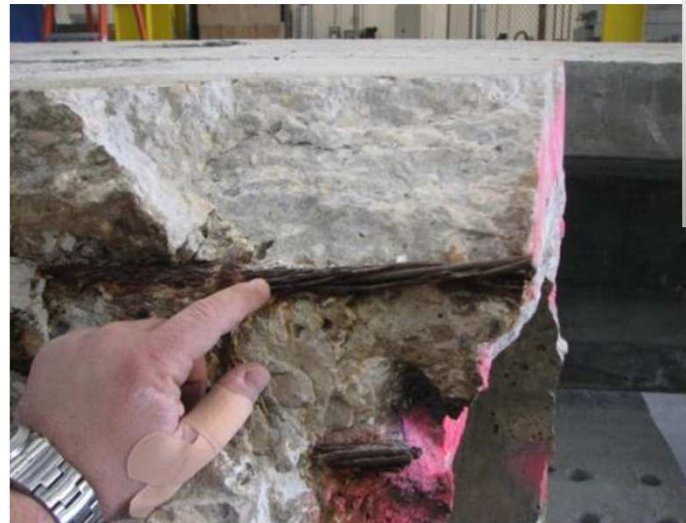
- Extensive longitudinal cracking of concrete
 - Cracking most extensive at corners
 - 2-D flow of chlorides decreases time to corrosion
- Cracking linked to corrosion observed in splash zone

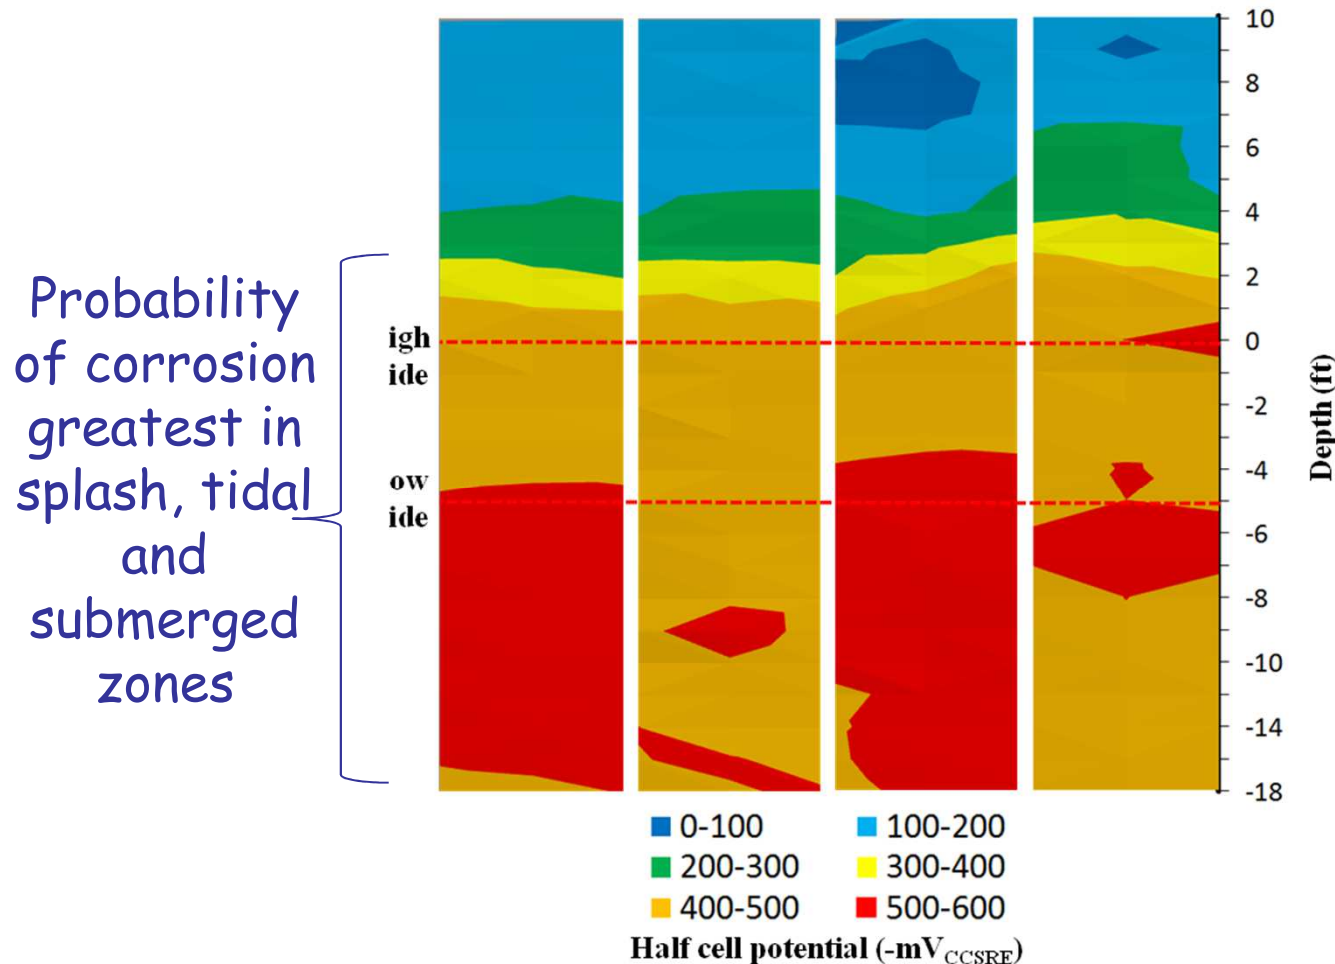
Corrosion potential mapping

- > 350 mV 90% or greater probability of corrosion
- < 200 mV 10% or less probability of corrosion
- Does not indicate rate of corrosion

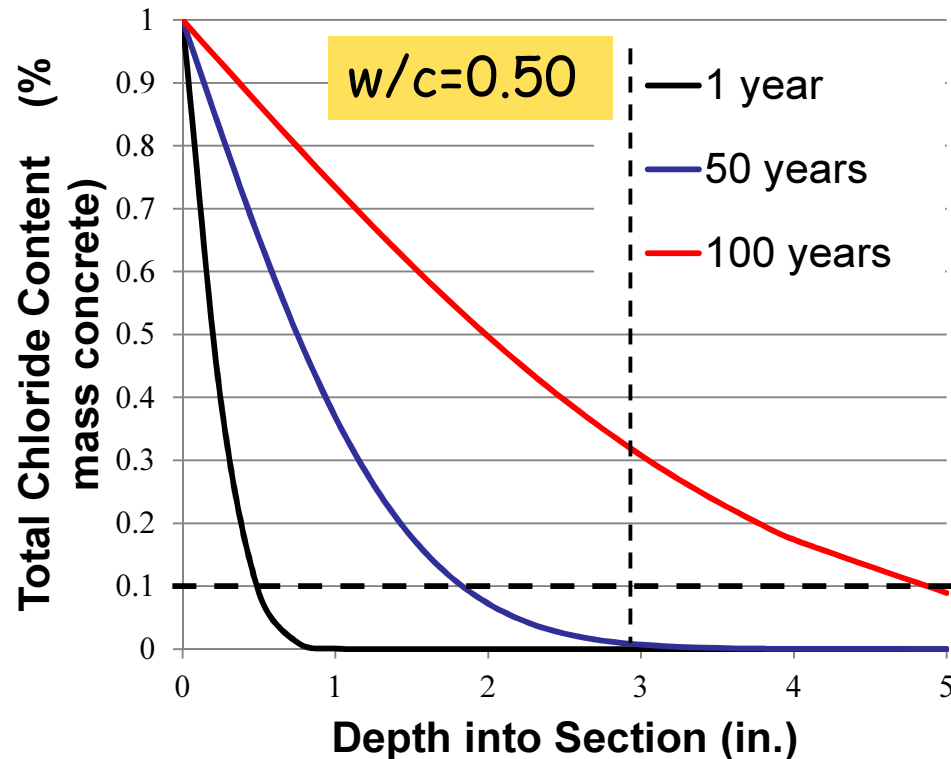
- Modeling suggests corrosion would not initiate for at least 50 years
- Why were piles removed after just 32 years of service?

Standard chloride modeling approaches do not account for cracking
